Coolant Intrusion in Mercedes EQ High-Voltage Battery Systems: Causes, Diagnostic Indicators, and the Risk of Unnecessary Battery Replacement

Samoilov Alexey

Automotive Workshop Master, Hilden, Germany.

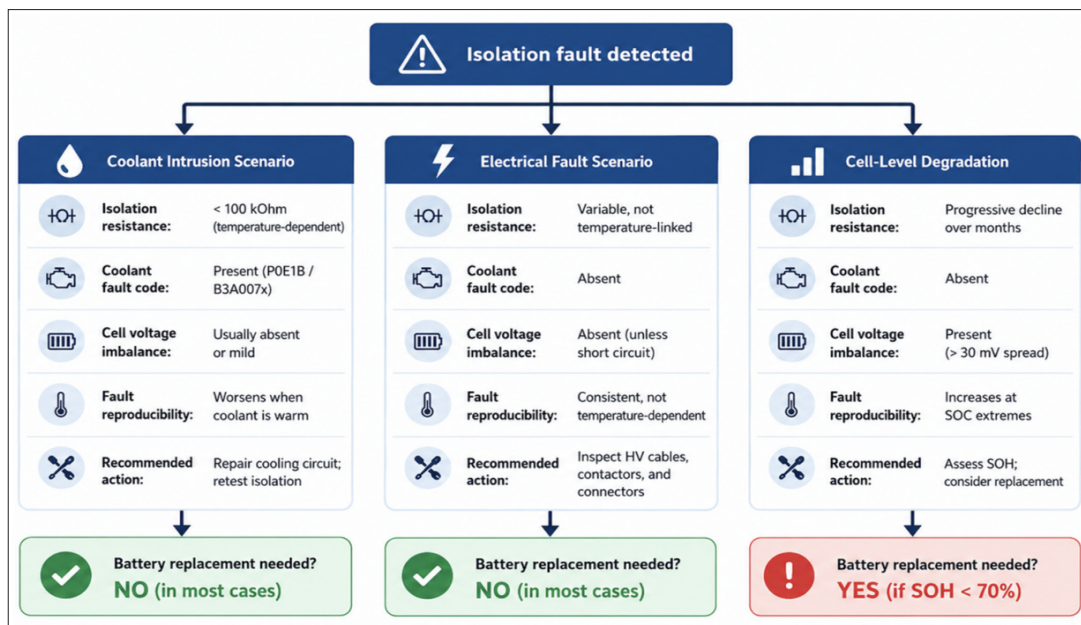
Figure 4. HV Battery Replacement Decision Matrix for Isolation Faults in Mercedes EQ Systems (author's original design based on [5, 8, 10, 14, 18, 19]).

The proposed decision matrix, presented in Figure 4, operationalizes the diagnostic logic described above into a reference tool for dealership technicians. It compares three primary scenarios against five diagnostic indicators and provides a binary recommendation on pack replacement. The matrix is intended to be applied after XENTRY fault code reading and before any disassembly of the battery pack.

The central recommendation of this matrix is that coolant intrusion and electrical fault scenarios should resolve without pack replacement in the majority of cases. Only confirmed cell-level degradation with state-of-health below 70% warrants a hardware replacement of the pack. This threshold aligns with federal and most state-level EV battery warranty standards, which require manufacturers to cover battery degradation below 70% of original capacity within the warranty period [6].
